Updated Firmware (H_5213) for V802D-WIR and V802D-W312MIR Cameras

General Description

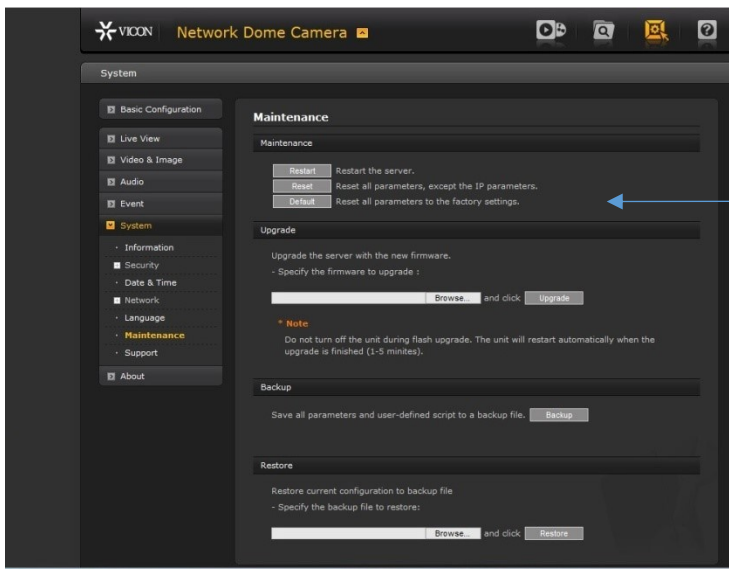
Download the firmware to your PC. Go to the camera's Maintenance screen:

Update firmware

Open the Upgrade section and use the Browse button to locate the firmware on your PC. Press the upgrade button. During the upgrade process, do not turn off power to the camera. Wait at least 5 minutes and access the camera again.

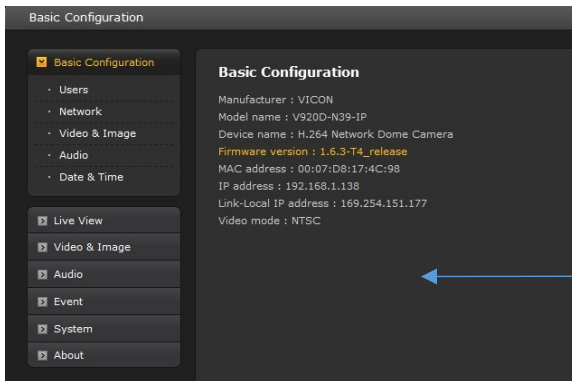
Once complete, the firmware version can be checked from the Basic Configuration screen.

Updated firmware
