Firmware Update for Select V2000 Series Roughneck Cameras, Introducing AI-Based Analytics

General Description

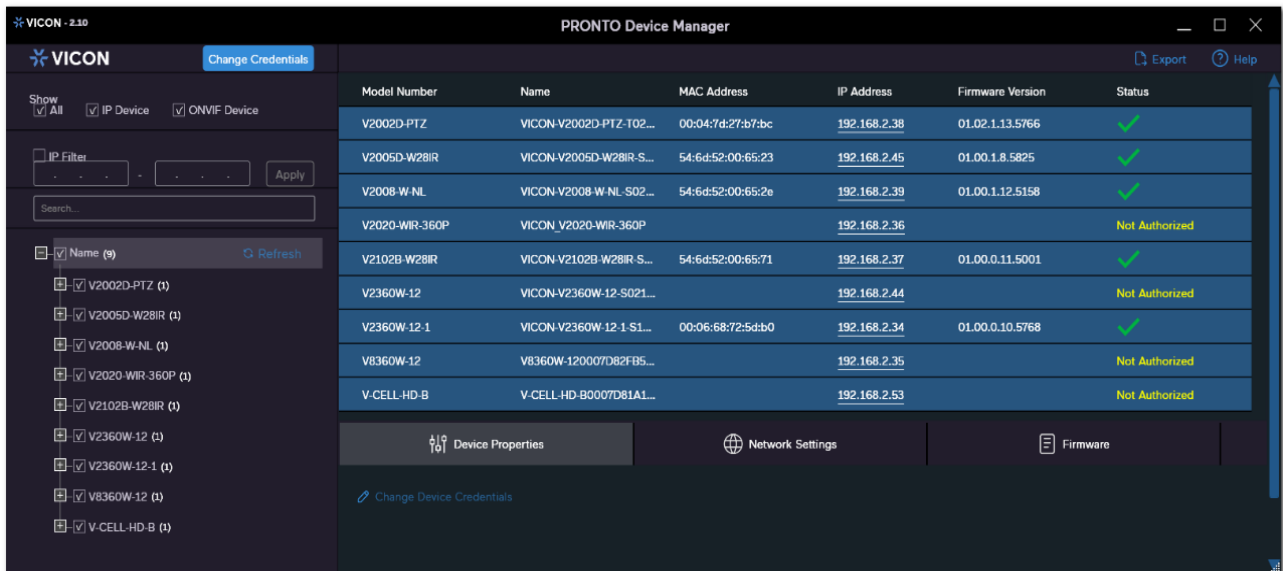
Using PRONTO Device Manager Software

PRONTO is Vicon's device manager tool that can be used to discover all Vicon cameras in a network. This standalone single discovery tool running on a PC, allows users to discover cameras in the network, configure network parameters and update camera firmware (single camera, or in batch)

To update firmware on one or more cameras:

- Scan the network and find the camera model that needs a firmware update.
- Enter valid credentials for the camera that needs a firmware update.
- Select camera(s). (More cameras can be selected that use the same firmware file.)
- Press the "Upload Firmware File" button; load the new firmware into Pronto.
- Press "Upgrade Device" and select the new firmware file just loaded into Pronto.
- Press Apply. The new firmware is now uploaded to the selected camera(s).
- Allow some time for the camera(s) to reboot after the firmware is uploaded.
- Press "Refresh" and verify the camera(s) are now listed with the new firmware version.
