V94x Camera Firmware

General Description

Vicon engineering has released updated firmware for the V94x family of cameras. The updated firmware is relevant to camera models as listed below:

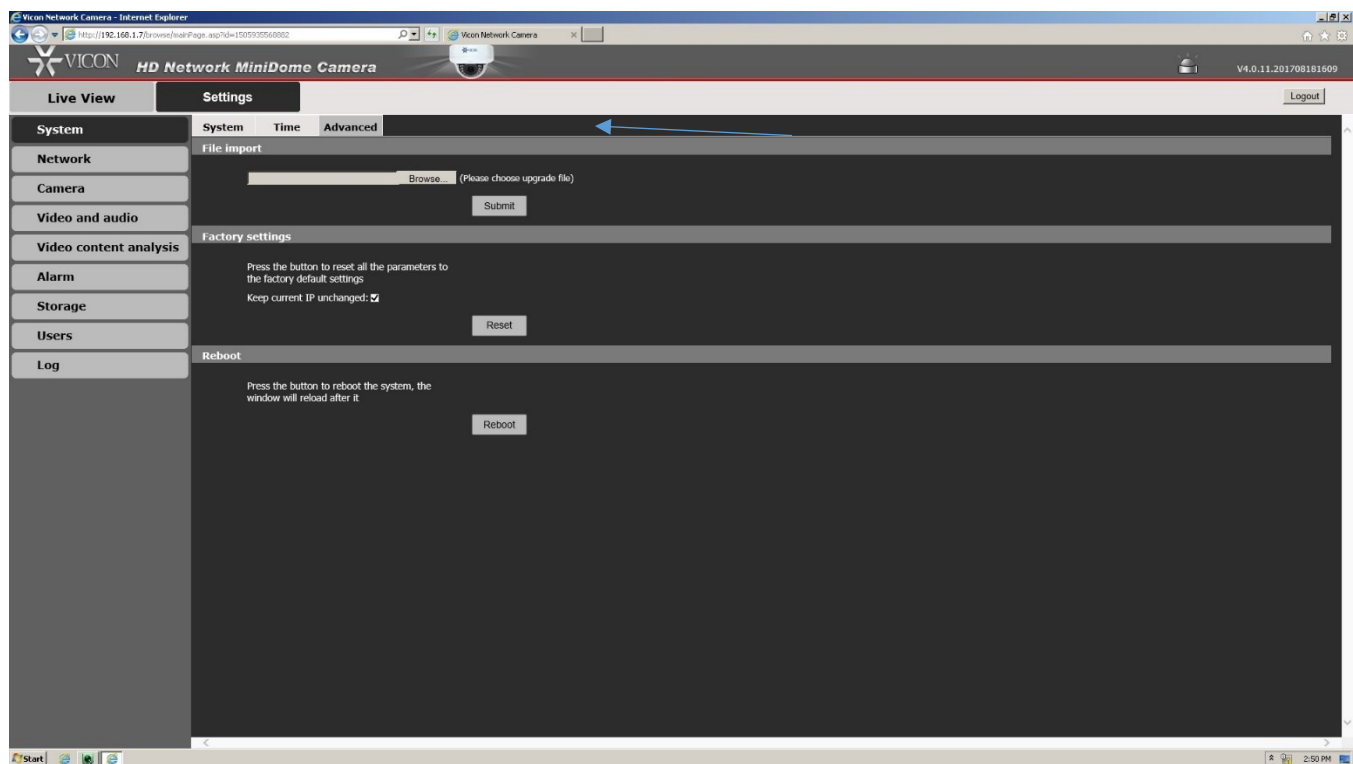
Download the firmware to your PC. Go to the camera's **Settings** page and open the **Advanced** tab. Go to the **File Import** section and use the **Browse** button to locate the firmware on your PC. Press the **Submit** button. During the upgrade process do not turn off power to the camera. Wait for the process to complete before attempting to access the camera.

When the camera reboots the updated firmware will be installed. This can be checked by verifying the firmware version loaded in the upper right corner of the **Settings** page.

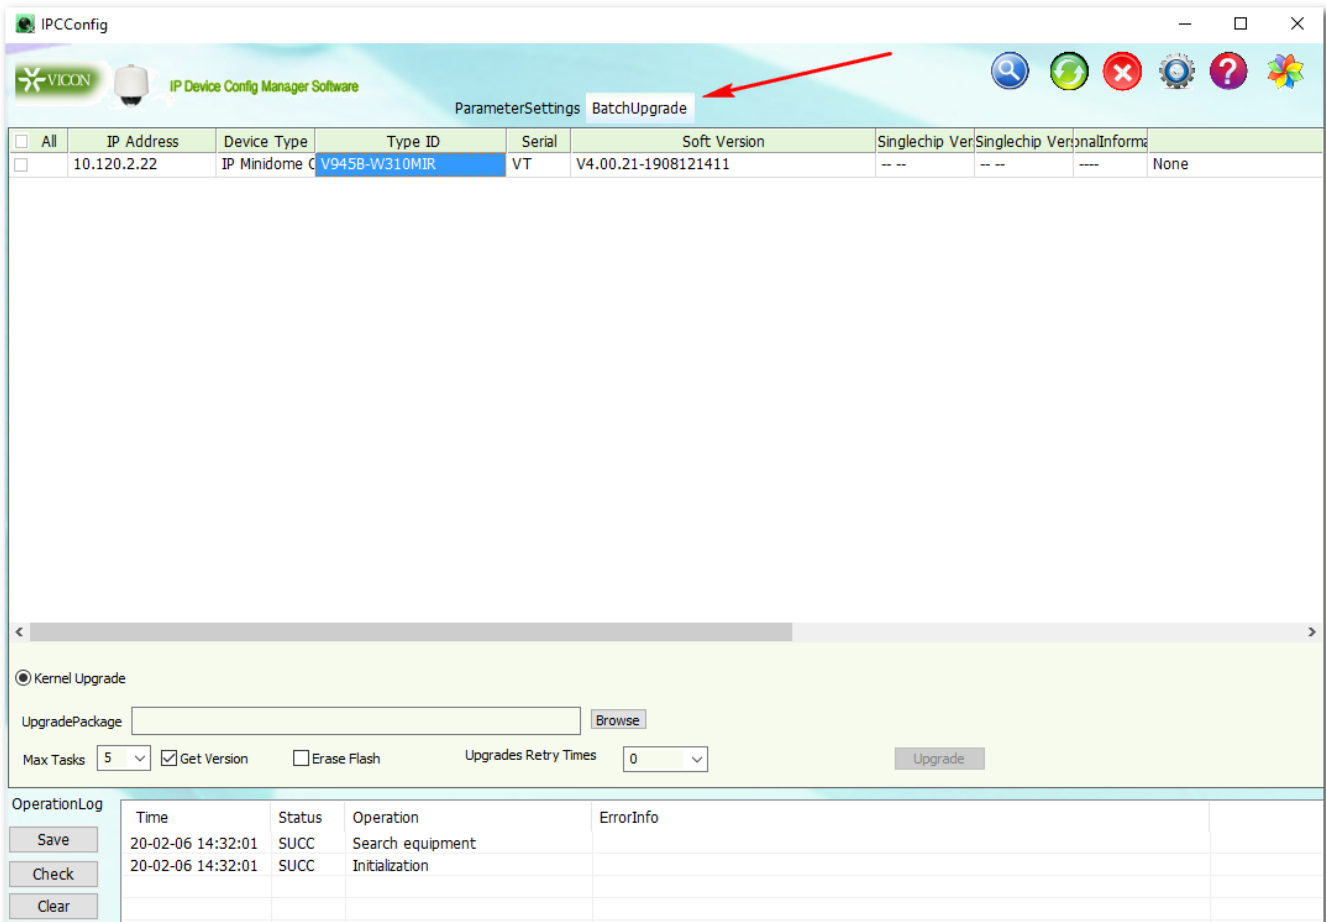
Then open the IPCConfig utility program and select 'Batch Upgrade'.

Select **Browse** button to locate the firmware on your PC. Select Open.

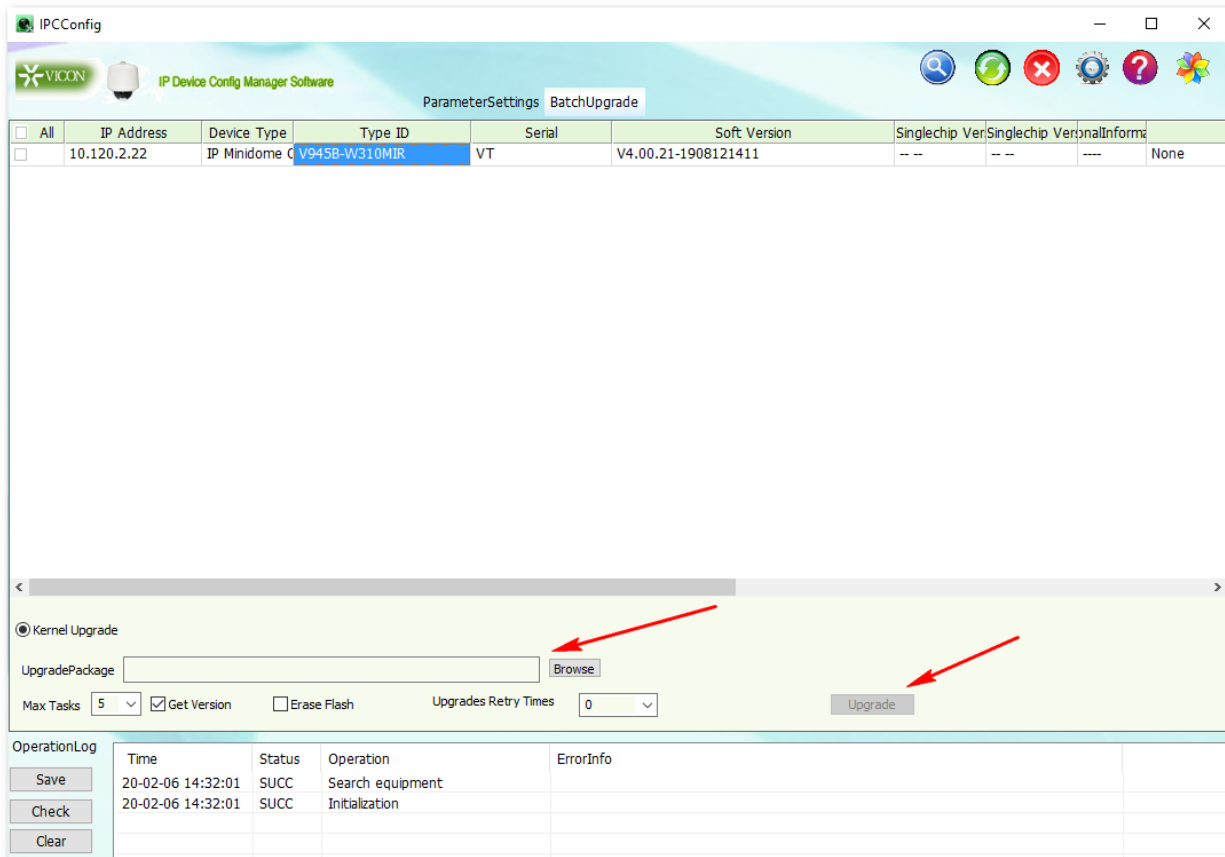
Select the cameras to upgrade from the Device list dialog box; an All option is available. Click OK. Select Upgrade. Select OK to continue.

After upgrade is completed, the upgrade status and firmware versions are displayed in the list.
