Updated Firmware for:

**V2008B-W310LPR, V2008-WNL-LPR, V2008-W1250-LPR,
V2008B-W818LPR and V2008-W0950-LPR
License Plate Recognition Cameras**

General Description

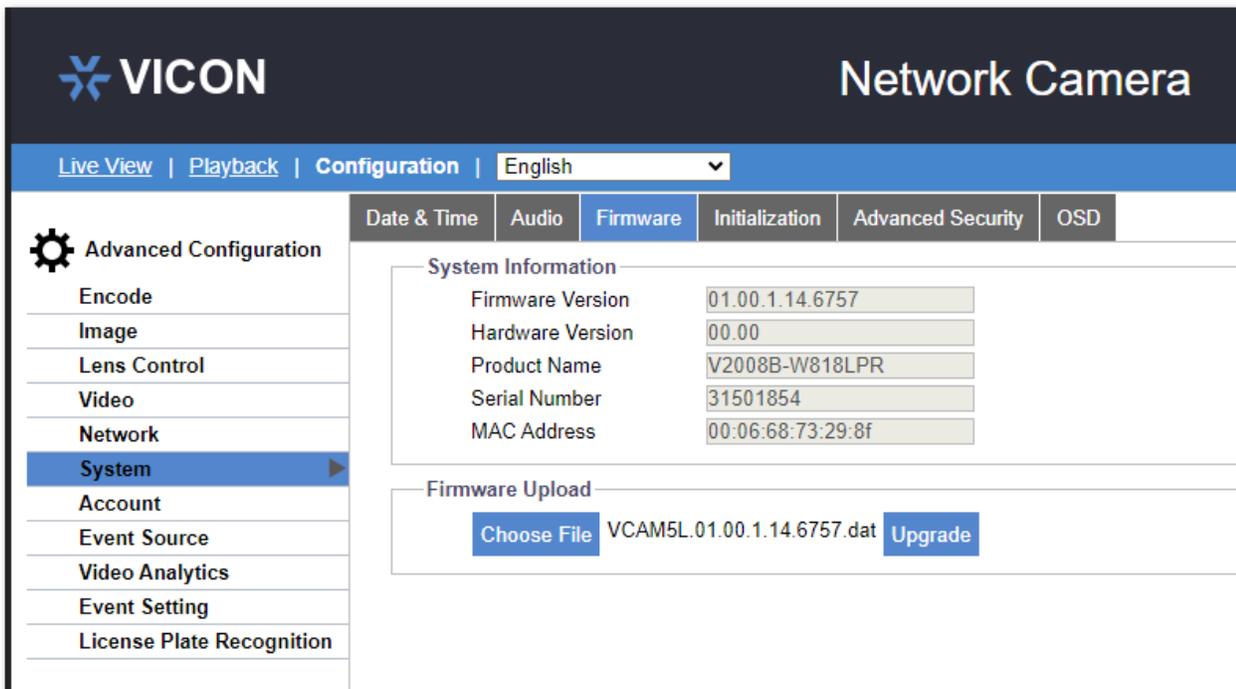
In the camera web interface, under Configuration > System > Firmware, press “Choose File” under “Firmware Upload” and select the downloaded firmware file. Then press “Upgrade” to start the update. The camera will install the update and reboot with the new firmware version:

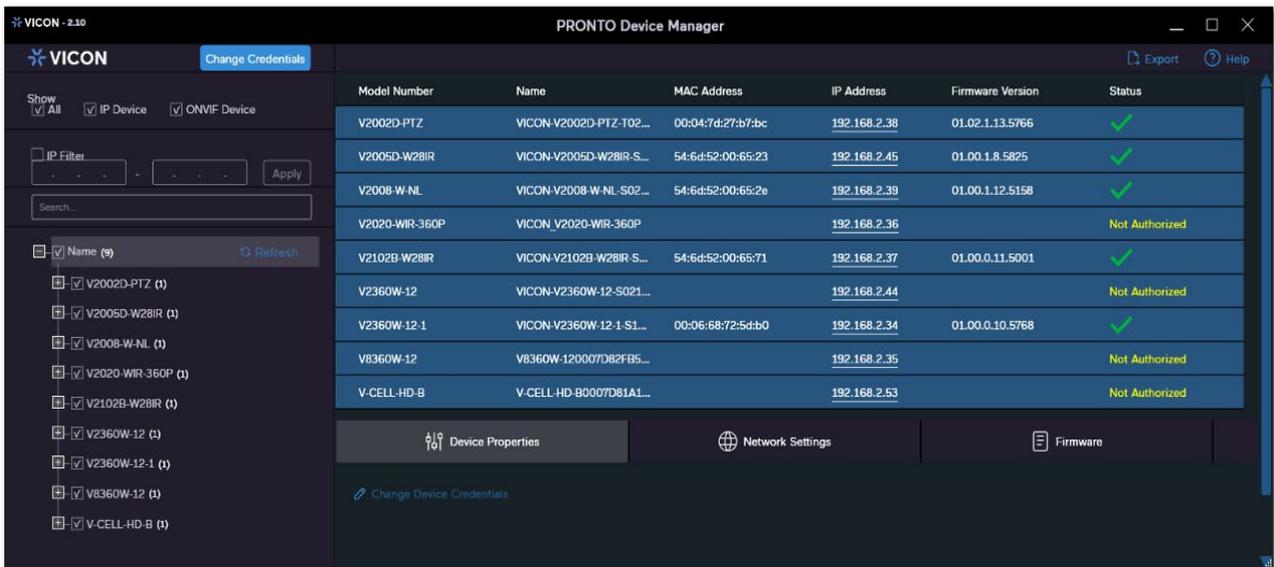
PRONTO is Vicon's device manager tool that can be used to discover all Vicon cameras in a network. This standalone single discovery tool running on a PC, allows users to discover cameras in the network, configure network parameters and update camera firmware (single camera, or in batch).

To update firmware on one or more cameras:

- Scan the network and find the camera model that needs a firmware update.
- Enter valid credentials for the camera that needs a firmware update.
- Select camera(s). (More cameras can be selected that use the same firmware file.)
- Press the "Upload Firmware File" button; load the new firmware into Pronto.
- Press "Upgrade Device" and select the new firmware file just loaded into Pronto.
- Press Apply. The new firmware is now uploaded to the selected camera(s).
- Allow some time for the camera(s) to reboot after the firmware is uploaded.
- Press "Refresh" and verify the camera(s) are now listed with the new firmware version.
