July 2023

Firmware Update for V2020-WIR-360 and V2032-WIR-360 Multi-Sensor Cameras, Introducing AI-Based Analytics

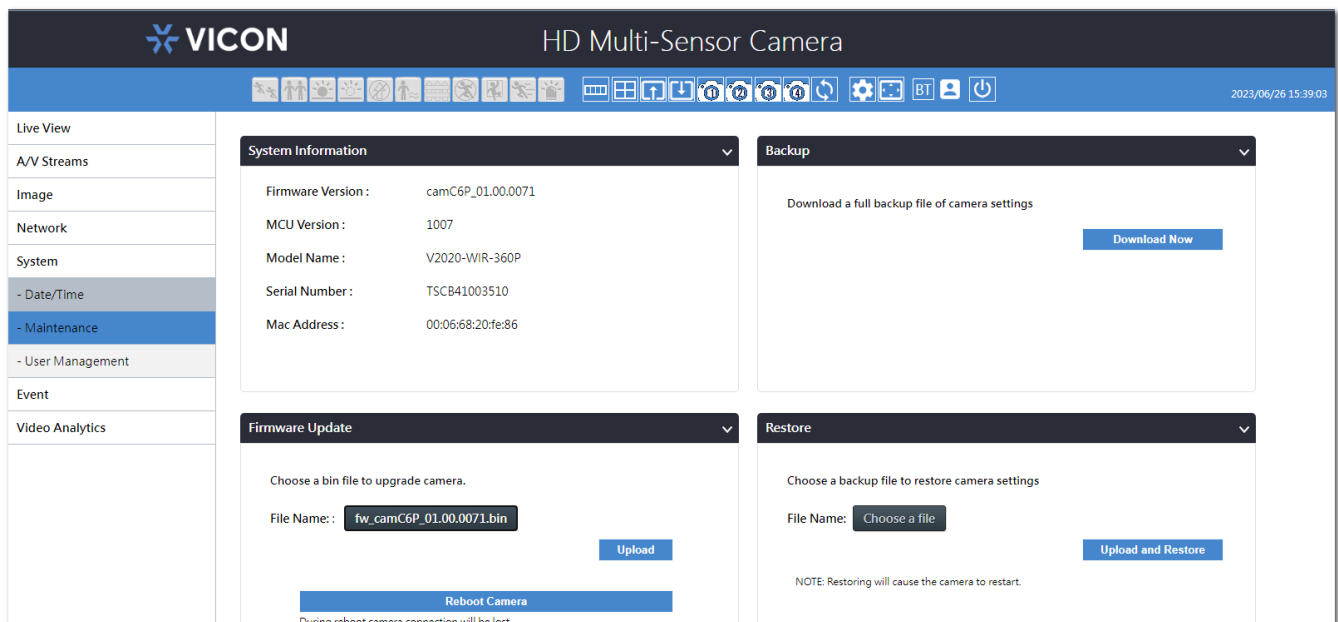
In the camera web interface, under Setup > System > Maintenance, press “Choose a File” under “Firmware Upgrade” and select the downloaded firmware file. Then press “Upload” to start the update. The camera will install the update and reboot with the new firmware version:

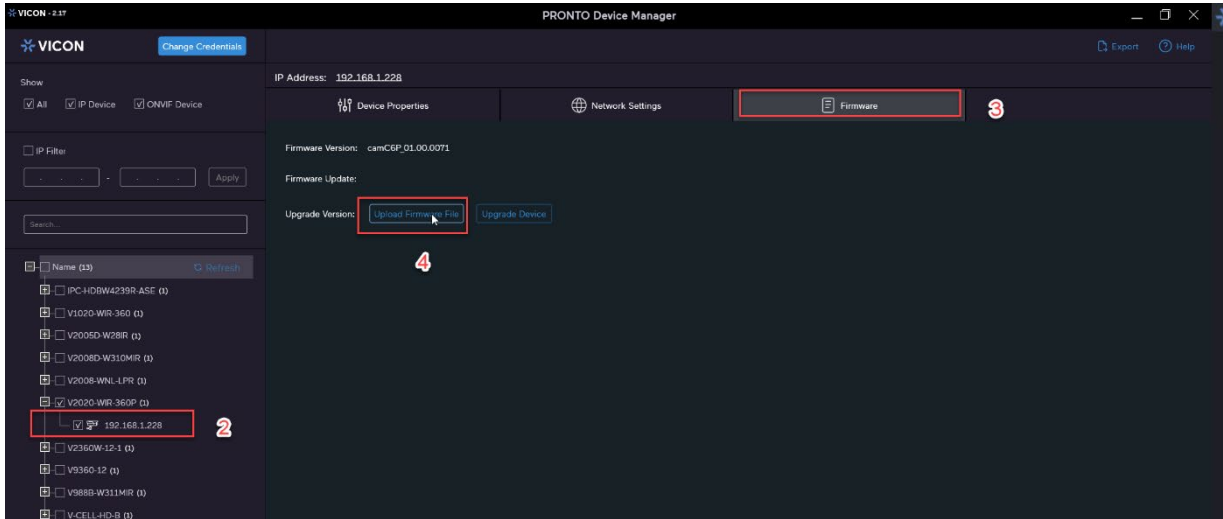
1. Download the file from the website, unzip it, and save it on your device.
2. In PRONTO, select the multi-sensor from the devices on the left.
3. Navigate to the Firmware tab.
4. Click "Upload Firmware File".

5. Select the firmware to add and click Open; once uploaded, it is available in the library to update the relevant cameras.
