Updated Firmware for V1000 Series Multi-Sensor Cameras

General Description

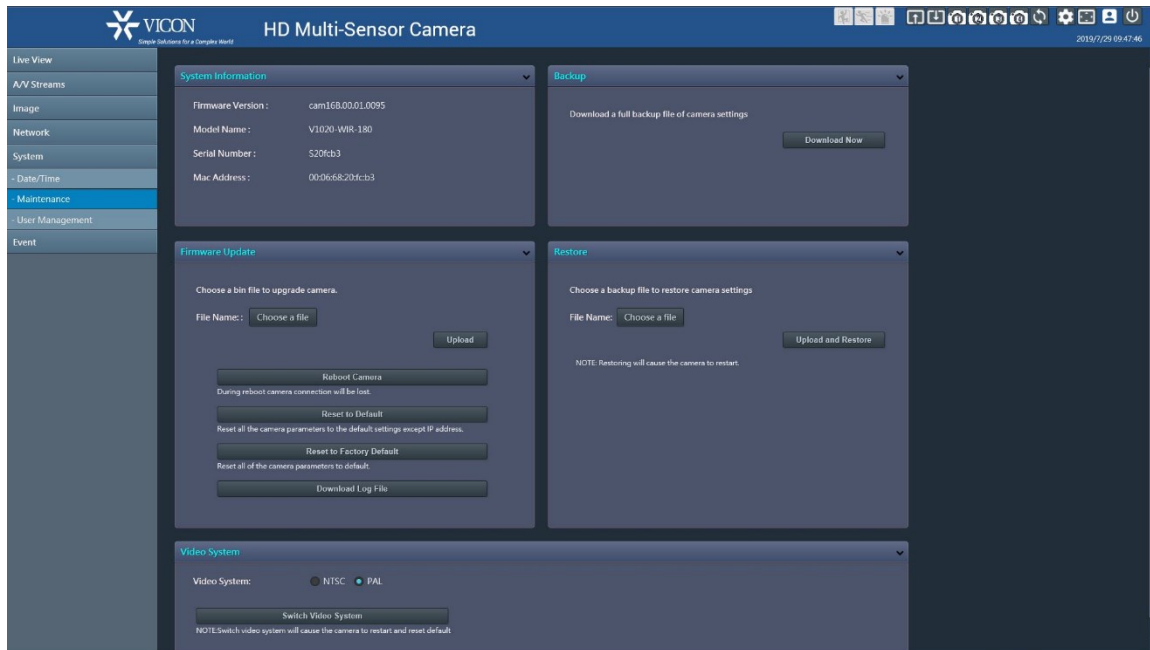
Download the firmware to your PC. Go to the camera's Maintenance screen. Click "Choose a file" to point to the new firmware file and select "Upload":

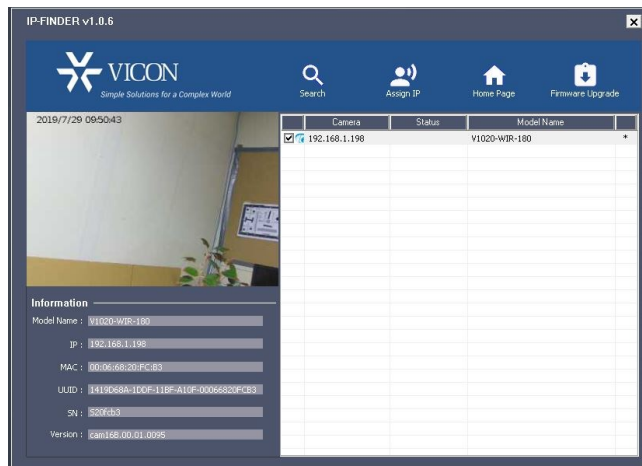
Alternatively, the Vicon IP Finder utility allows updating multiple cameras at the same time:

The accompanying Vicon IP Finder discovery tool that needs to be used with this firmware release is version 1.0.6. It can be downloaded from Vicon's website.
